Manhole Inspection Summary

Manhole # S33KK_024MH

Insp Date: **12/6/06 11:13 AM**

Location Address: **1733 MARYLAND AVE**

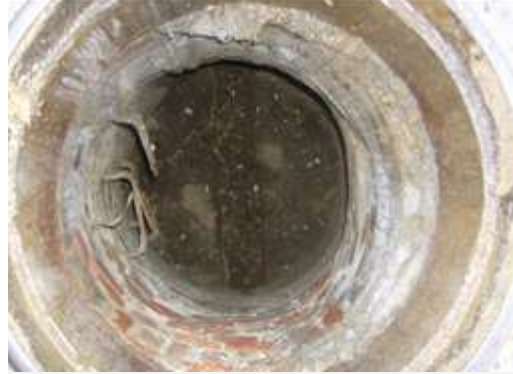
Top View

Corroded and missing steps. Bench and Channel debris.

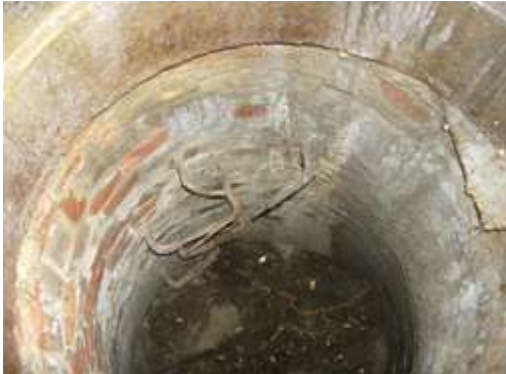
Defect

Frame leaks. Adjustmnt deterioration, loose brick and infiltration. Barrel infiltration.

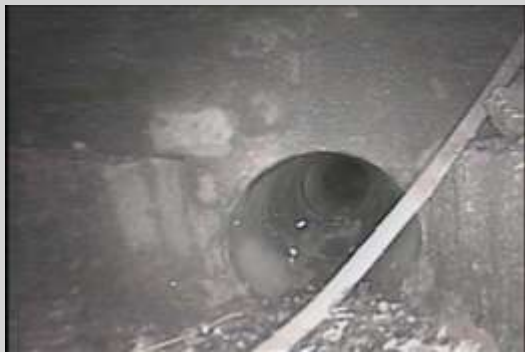
8 in. Circular Gravity Sewer Pipe Out @ 12 O'Clock

Deposits: ☐ None ☒ **Mud** ☐ Sludge ☒ **Debris** ☐ Grease

Silt Depth: **0** (in.) Deposits Extent: **Light**

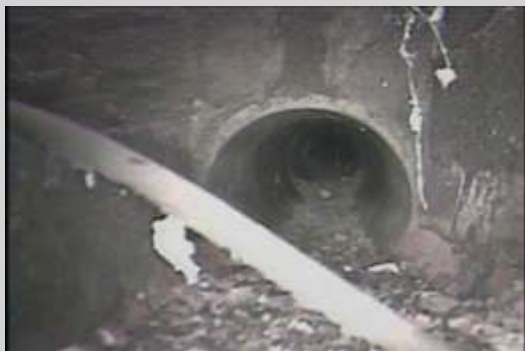
8 in. Circular Gravity Sewer Pipe In @ 6 O'Clock

Deposits: ☐ None ☒ **Mud** ☐ Sludge ☒ **Debris** ☐ Grease

Silt Depth: **0.5** (in.) Deposits Extent: **Light**

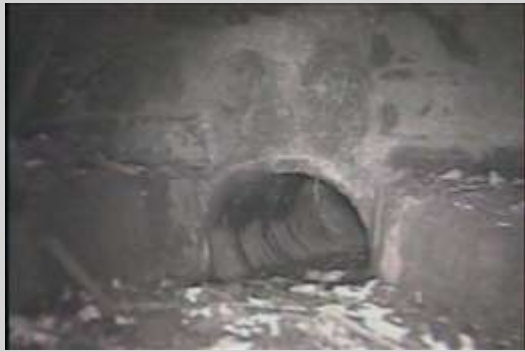
6 in. Circular Gravity Sewer

Deposits: ☐ None ☒ **Mud** ☐ Sludge ☒ **Debris** ☐ Grease

Silt Depth: **1** (in.) Deposits Extent: **Light**

Infiltration: **Evidence**
